CRS Site – Elyria, Ohio

AGWS-S Data Review

Brown AND Caldwell

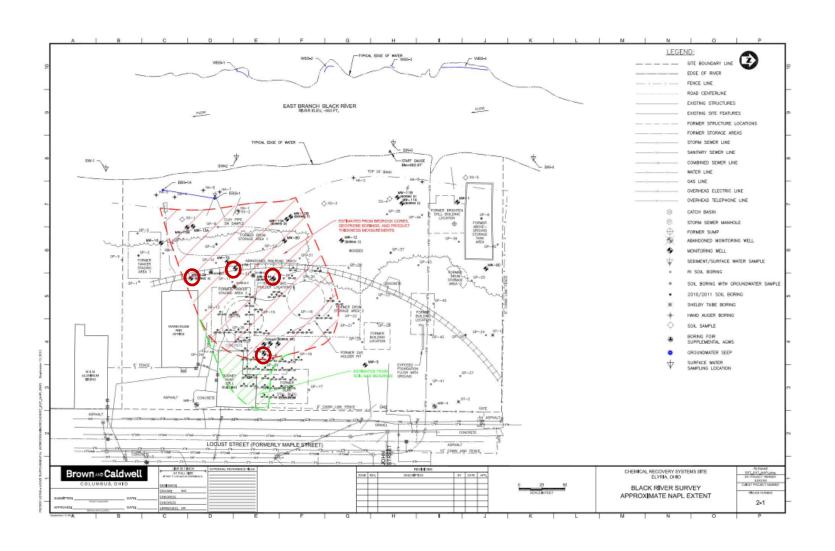
NAPL Recovery Tests-Results

- Field data indicates LNAPL has limited mobility and recoverability.
 - No LNAPL or DNAPL observed in wells MW-6 and MW-13A (wells where NAPL historically observed).
 - Limited observations of globules of NAPL in MW-7A and MW-14A; but could not recover any during testing.
 - The absence of NAPL precluded bail down testing.

Conclusion the majority of the mass is trapped as residual NAPL within the rock matrix.

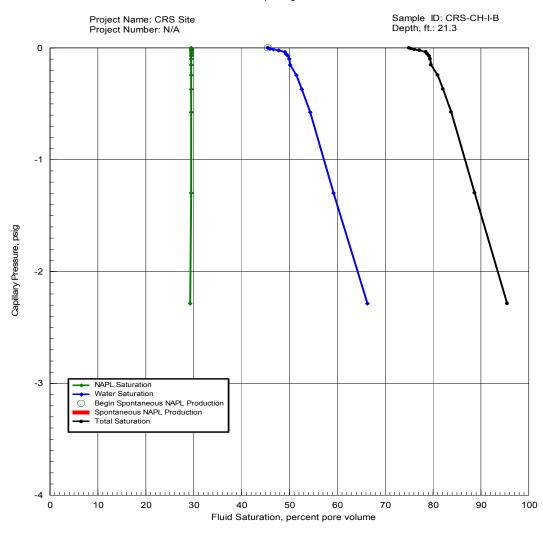
NATIVE STATE (AS-RECEIVED) CAPILLARY PRESSURE Centrifugal Method

Imbibition: Water Displacing Oil - ASTM D6836

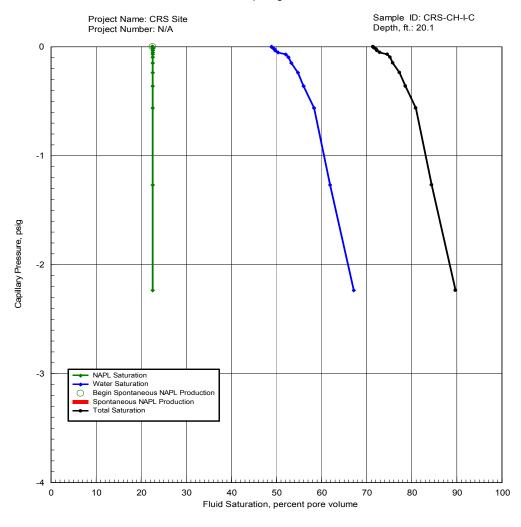
NATIVE STATE (AS-RECEIVED) CAPILLARY PRESSURE Centrifugal Method

Imbibition: Water Displacing Oil - ASTM D6836
